Supersonic Particle Deposition for Repair and Corrosion Protection of Mg Gearboxes

ASETSDefense Work Shop Sept. 2, 2009

Brian M. Gabriel, Phillip F. Leyman, Dennis J. Helfritch, and Victor K. Champagne* ARL Center for Cold Spray

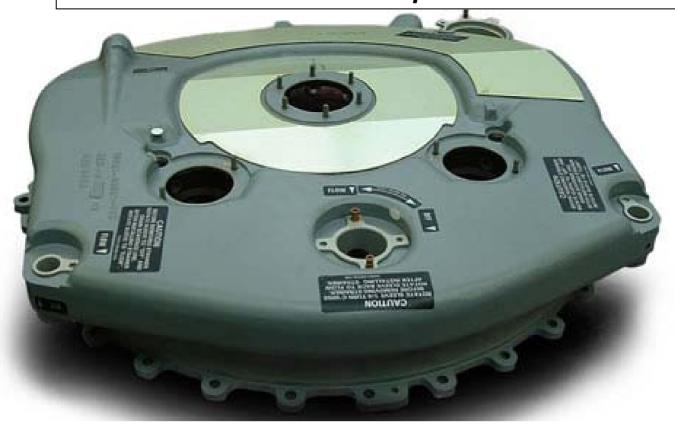
UH-60 Sump Assembly Main Module-Main Gearbox Repair

- •Cost of new component \$11,000.00 DLA (Defense Logistics Agency)
- •85 sumps need repair per year based on a Sikorsky study over the last 3 years
 - •Total Replacement Cost Savings estimated to be \$935,000.00/year

Substrates: ZE41A & AZ91C Magnesium Coating Material: CP-Aluminum and/or 6061 Al

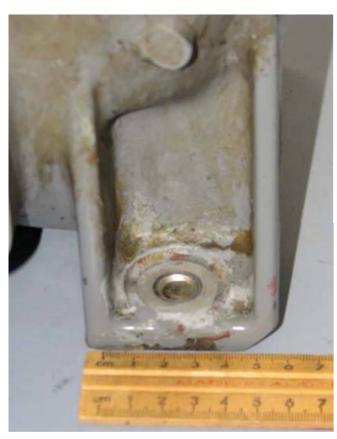
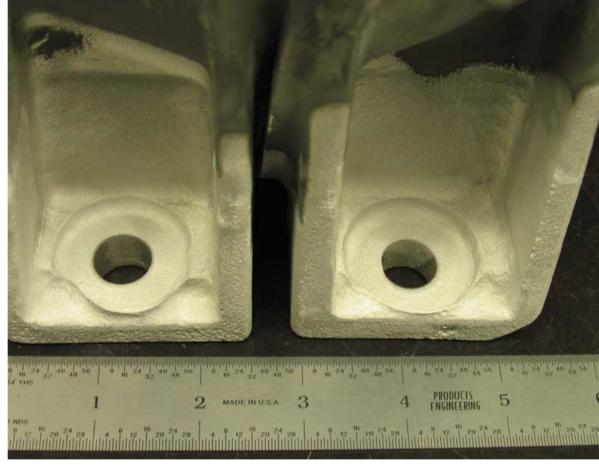
Interior section of IGB pads coated with CP-aluminum

Pre-Cold Spray

CP Al Cold Spray

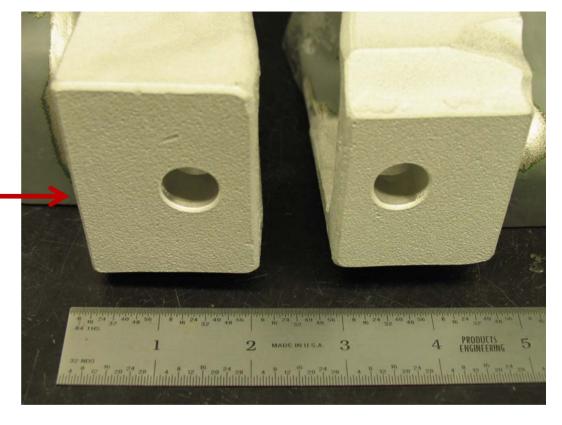
CP Al Cold Spray

Overview of 2008/Early 2009 Technical Progress: DSTO
